EAST PIERCE FIRE & RESCUE CAPITAL FACILITIES PLAN

BONNEY LAKE, WASHINGTON

Revised: July 17, 2018

Re: EPF&R Capital Facilities Plan Update

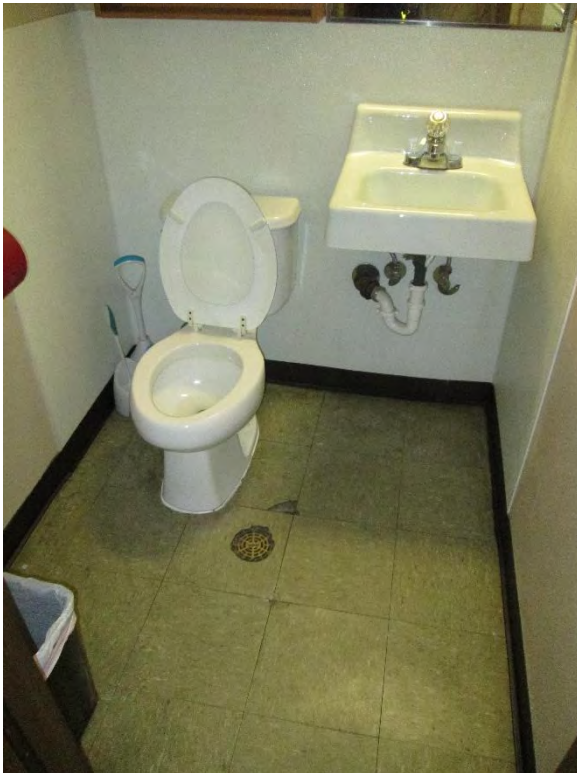
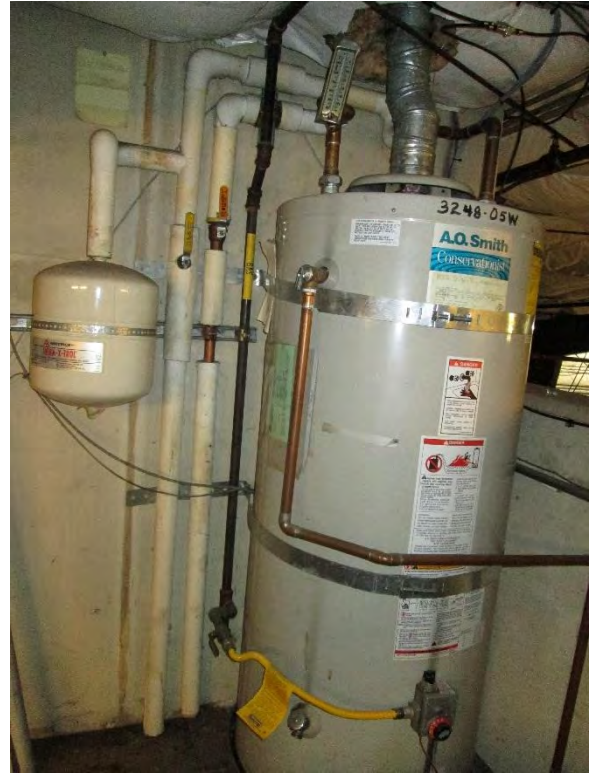
- h. Domestic hot water: The building is served by a 75 gallon gas fired water heater with 75 MBH input. This water heater is at the end of useful service.

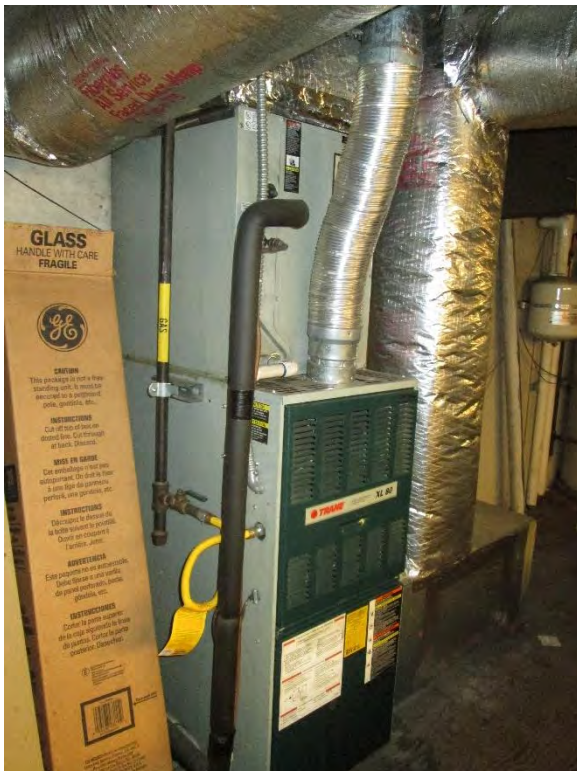
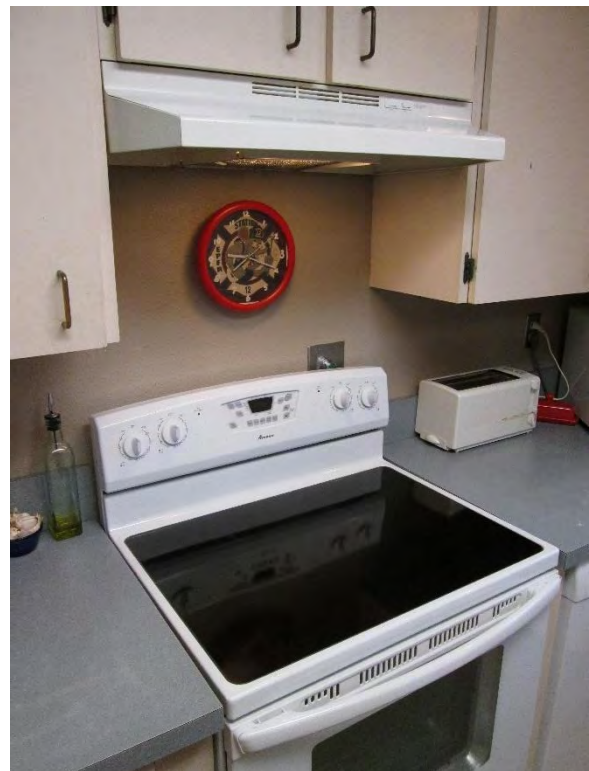
- f. Kitchen: The kitchen has a residential style electric range with a residential type range hood exhaust. This hood offers limited odor and

grease capture and should be considered inadequate for this application. There does appear to be an electrical appliance disconnect on station alert.

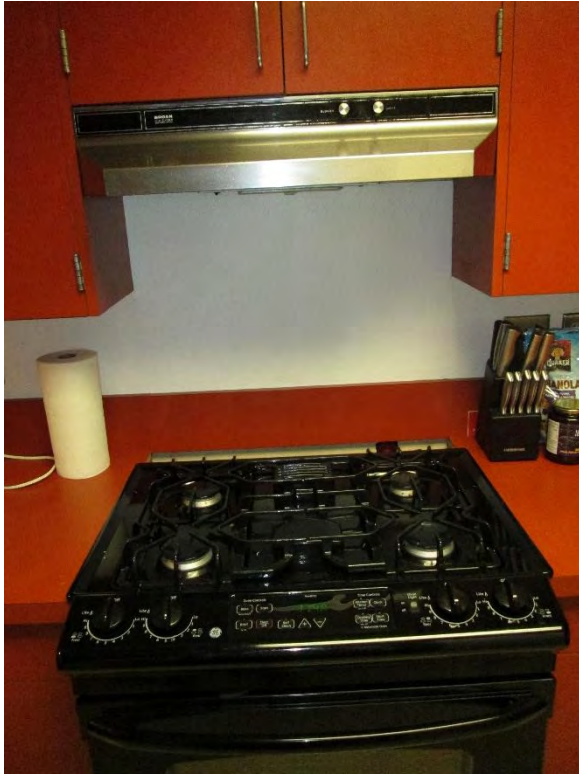
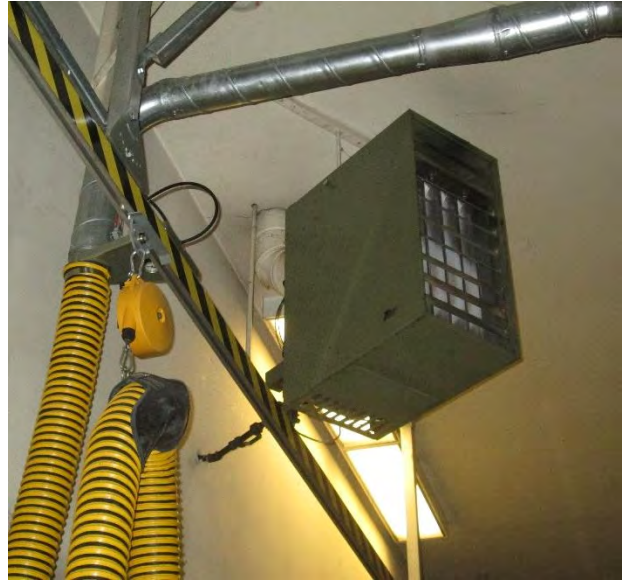
- e. Kitchen: The kitchen has a residential style gas range with a residential type range hood exhaust. This system offers limited odor and grease capture and should be considered inadequate for this application. There does appear to be an appliance disconnect on station alarm.

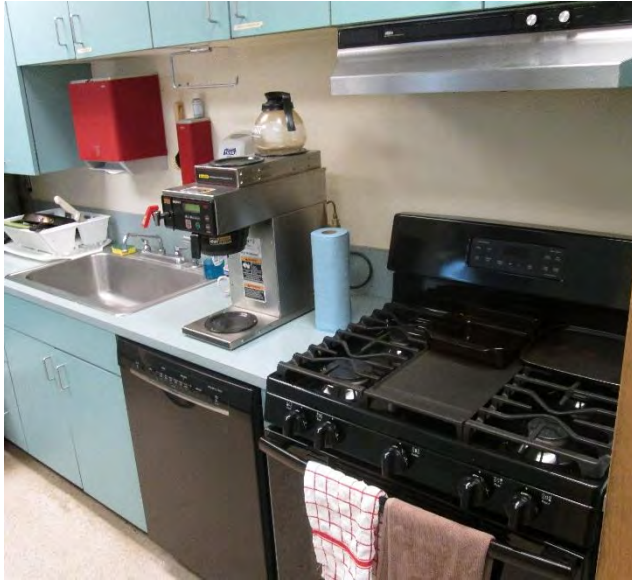
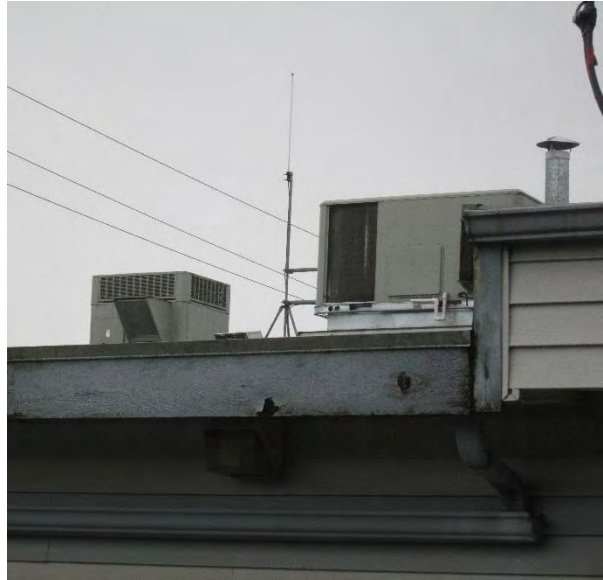
- f. Kitchen: The kitchen has a residential style gas range with a residential type range hood exhaust. This system offers limited odor and grease capture and should be considered inadequate for this application.
