EAST PIERCE FIRE & RESCUE CAPITAL FACILITIES PLAN

BONNEY LAKE, WASHINGTON

Revised: July 17, 2018

Re: EPF&R Capital Facilities Plan Update

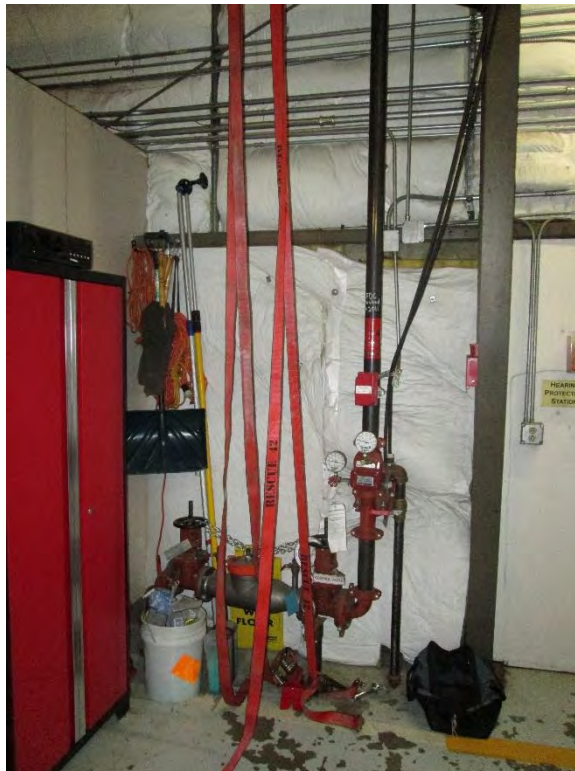
1. **Fire Sprinklers:** The building has a full coverage wet sprinkler system.

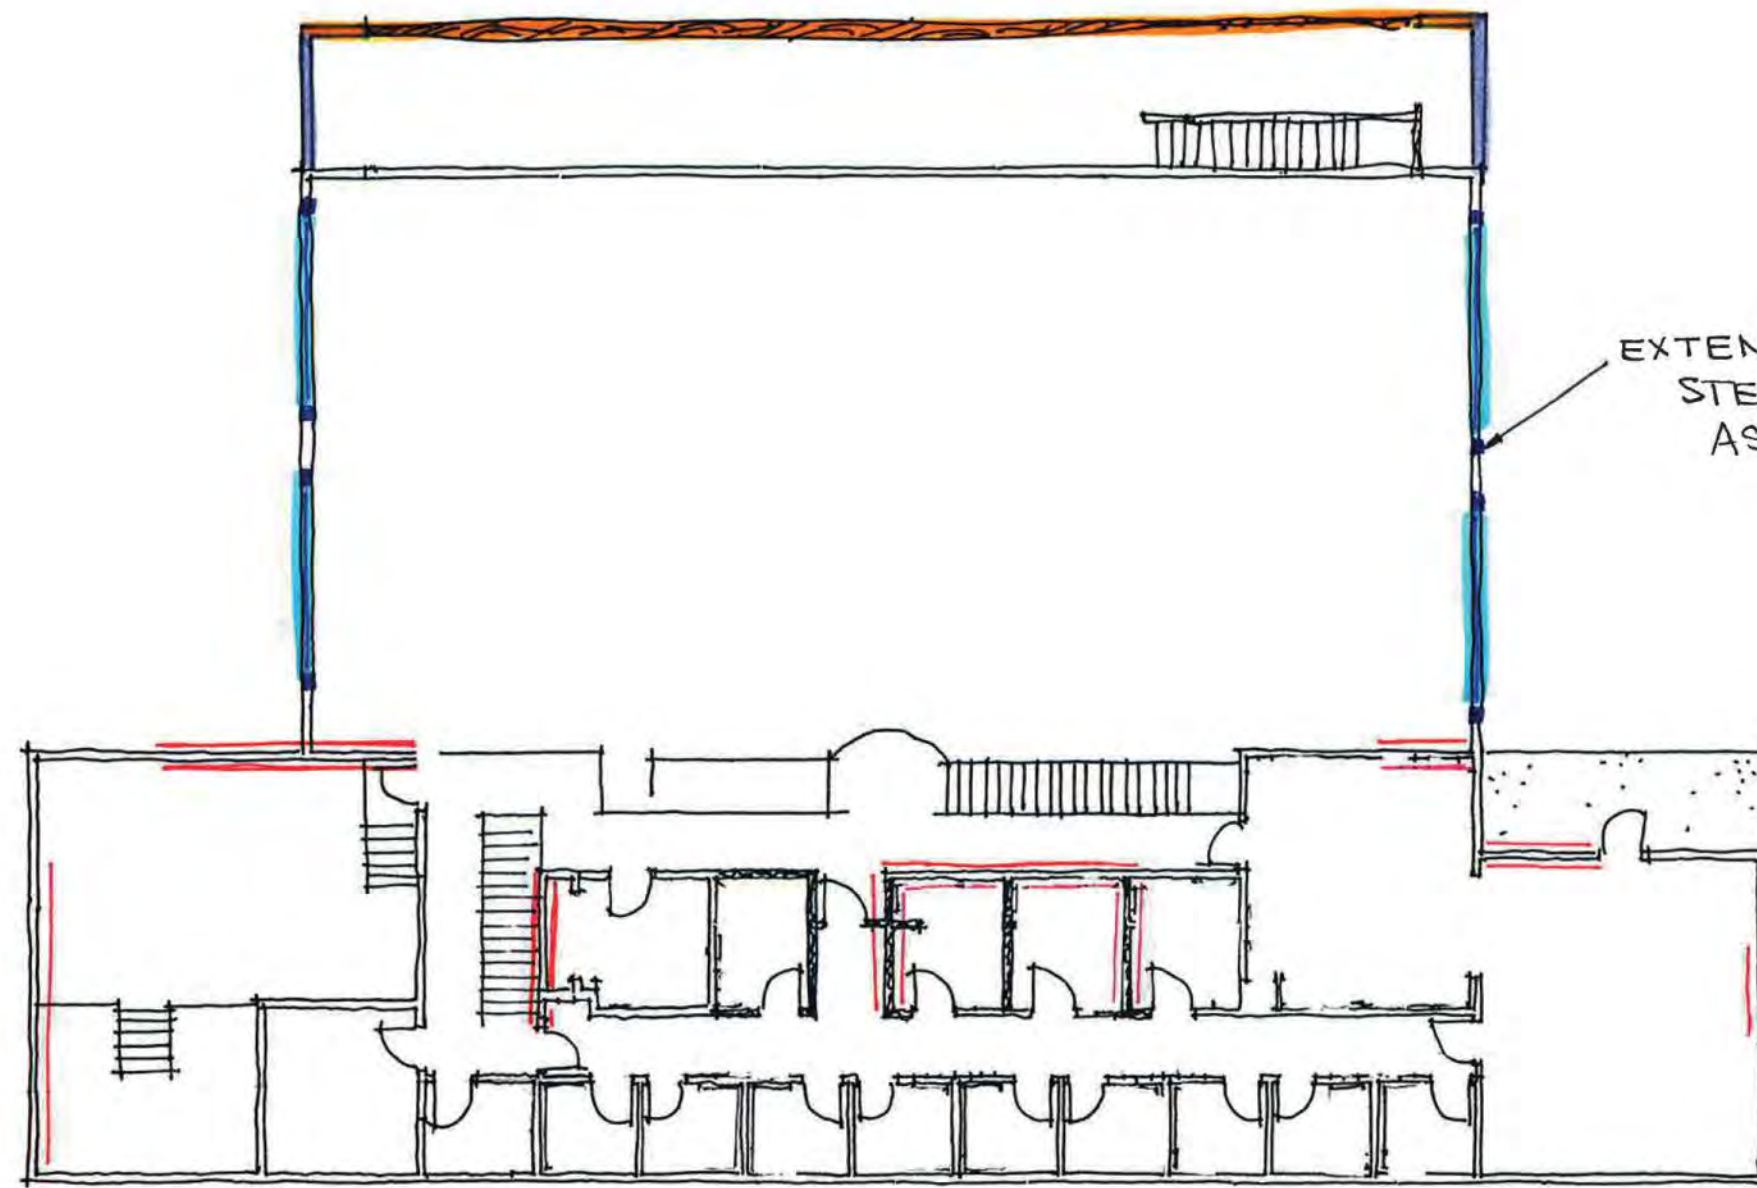
The concept for Station 113 includes adding nailing, blocking, and drag struts to the existing roof system. New wood shear walls would be added to the building's interior and exterior to provide additional strength and stiffness and reduce the roof diaphragm spans. The concept includes raising the apparatus door headers and adding masonry shear walls in the transverse direction of the apparatus bay. Ground improvements, such as compaction grouting beneath the existing building, may be required to mitigate settlement resulting from soil liquefaction. A site geotechnical investigation should be conducted prior to final design to further develop recommendations and identify the site's true potential for liquefaction. The addition of these new elements will strengthen and stiffen the building, providing better seismic performance.

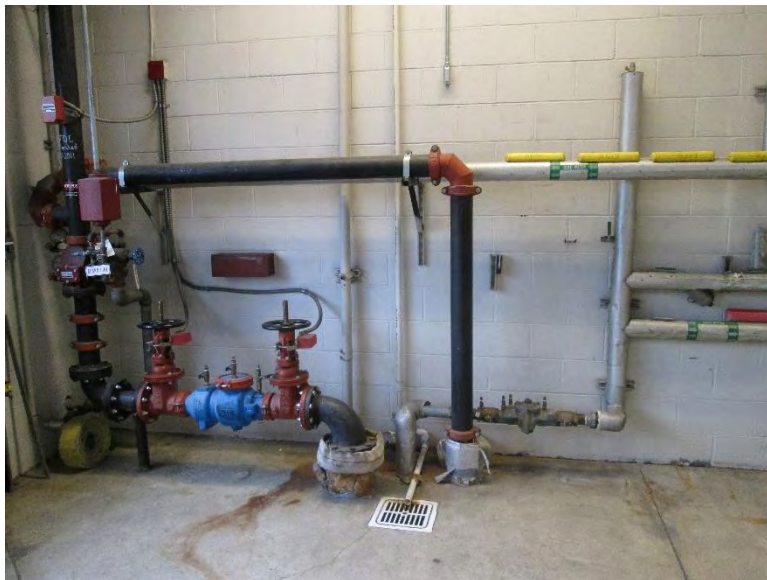
1. **Fire Sprinklers:** The building has a full coverage wet sprinkler system.

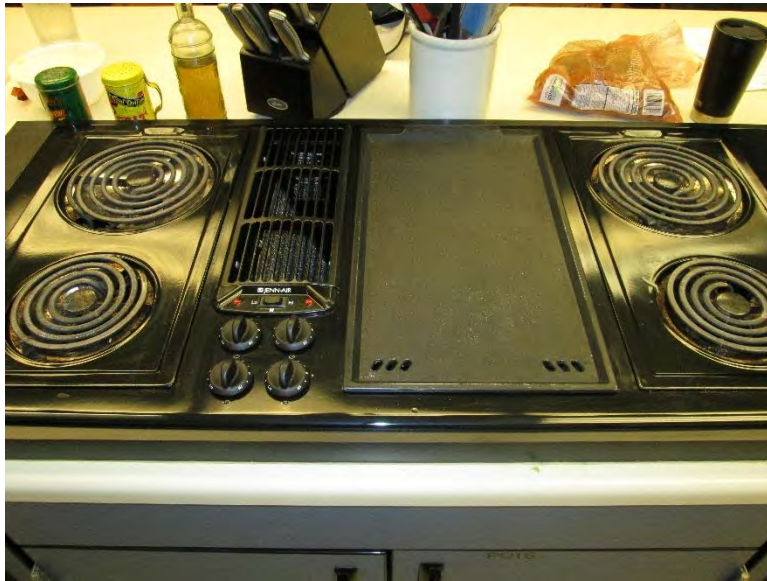
negligible odor and grease capture and should be considered inadequate for this application. There are also a pair of built-in ovens and microwaves.

- 1. Operational Related:**
 - a. Plan on providing HVAC capability for individual temperature control in single sleep rooms.
 - b. The existing HVAC equipment is of residential quality which does provide a low cost solution. While this was typical for fire stations of this era, residential equipment cannot provide the functional and quality requirement of a modern staffed fire station. We recommend that future HVAC system use commercial/institutional equipment which can provide:

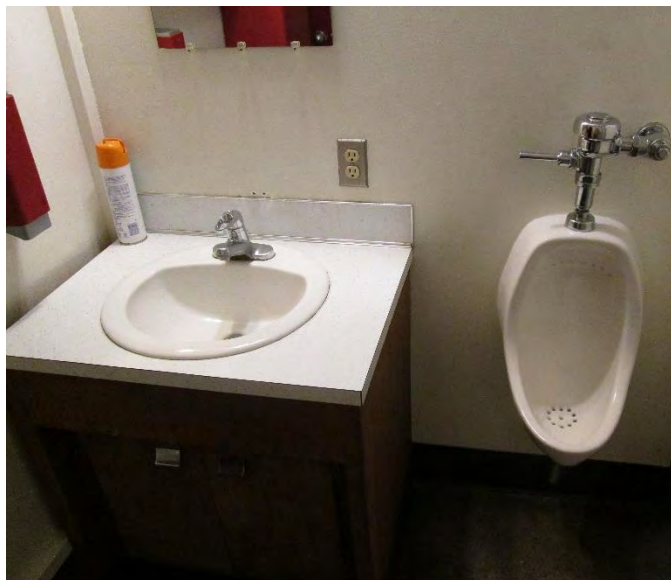
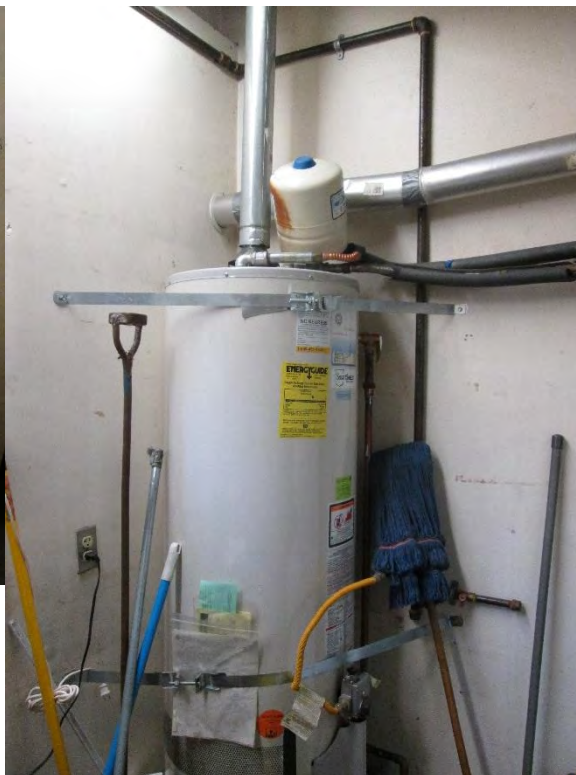
- g. Drains: There are no drains in the apparatus bay.
 - h. Piping: The domestic water service pipe is copper and is insulated.
 - i. Domestic hot water: The building is served by a 50 gallon gas fired water heater with 40 MBH input, in good condition.

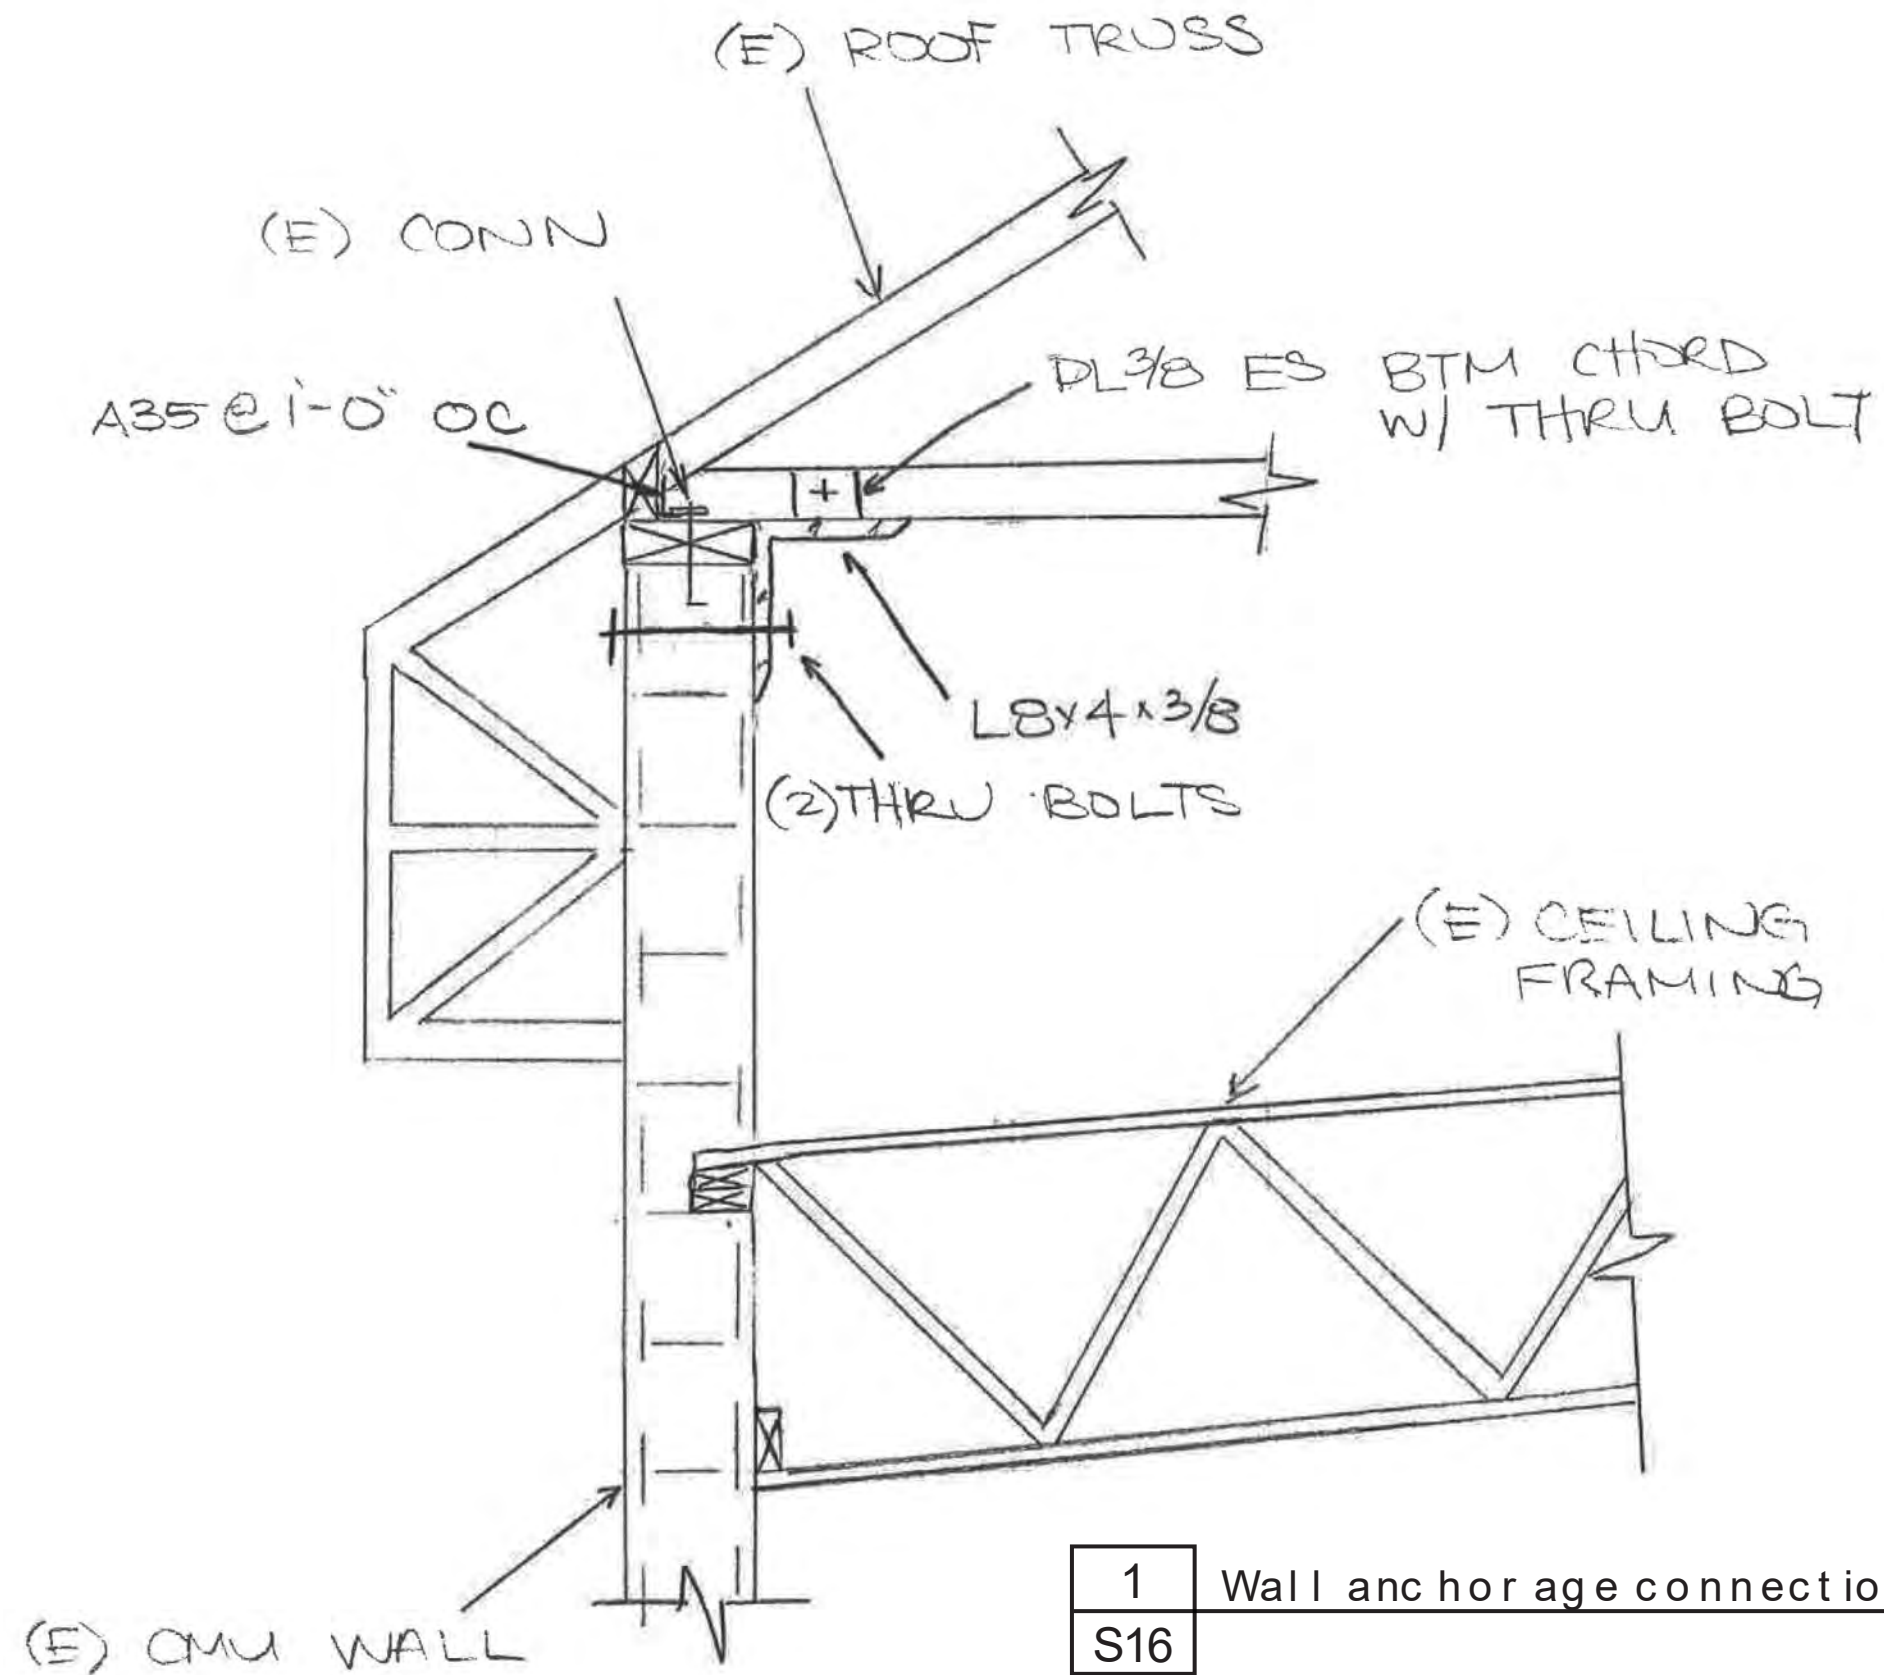
The concept for Station 116 includes adding blocking and drag struts at the roof diaphragms, adding out-of-plane wall ties at the masonry walls, and strengthening portions of the existing masonry walls by adding shotcrete. The concept also proposes to add plywood sheathing and hold-downs to existing wood perimeter walls. Ground improvements, such as compaction grouting beneath the existing building, may be required to mitigate settlement resulting from soil liquefaction. A site geotechnical investigation should be conducted prior to final design to further develop recommendations and identify the site's true potential for liquefaction. The addition of these new elements will strengthen and stiffen the building, providing better seismic performance.

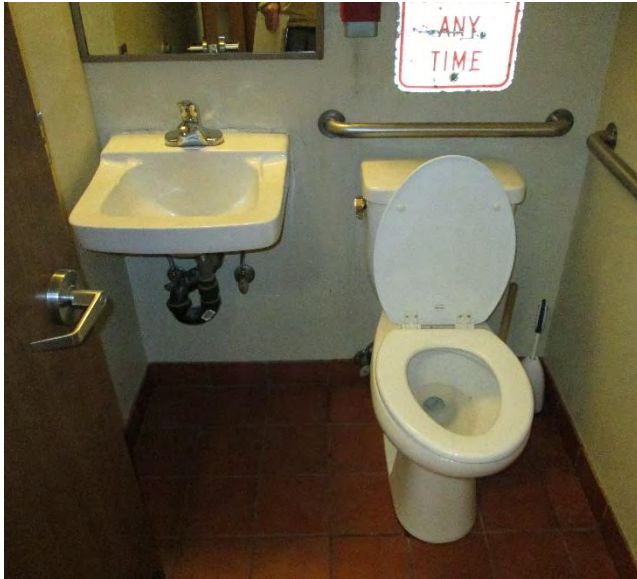
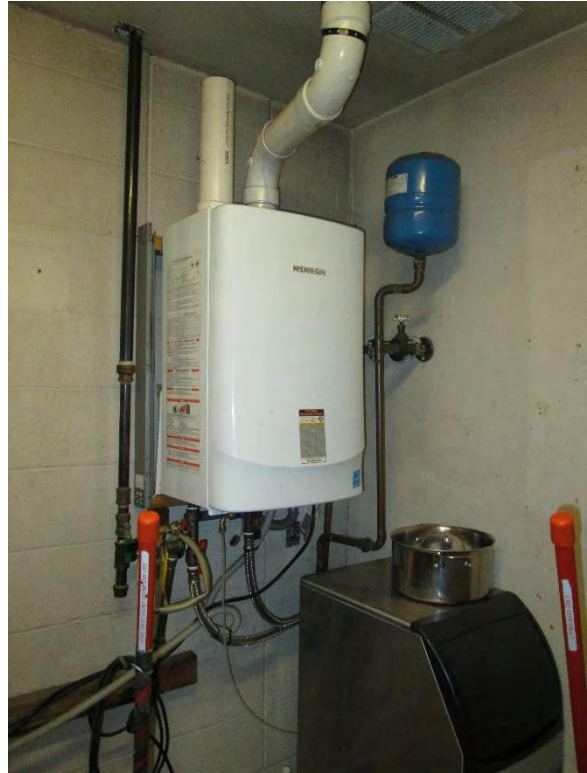
- h. Domestic hot water: Gas-fired instantaneous water heater, in good condition.
 - i.

- j. Compressed air: The station has a shop air compressor which is older, adequately sized and in serviceable condition.

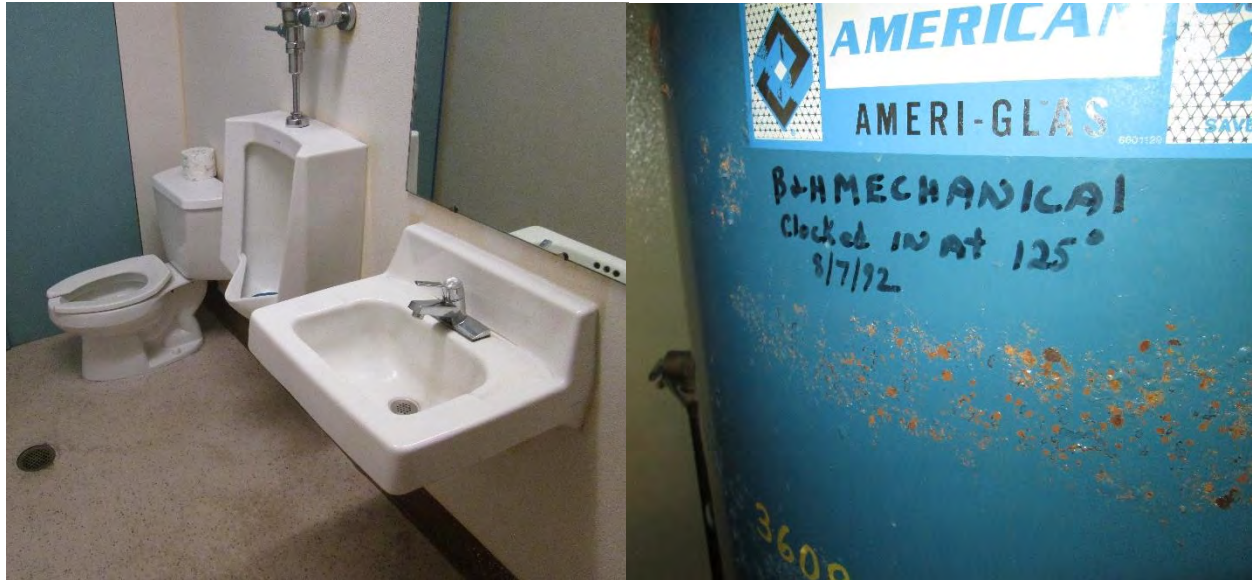
- i. Domestic hot water: The building is served by a 100 gallon gas fired water heater with 80 MBH input. This water heater is old and at the end of useful service.

- j. Compressed air: The station has a shop air compressor which is adequately sized and in good condition.

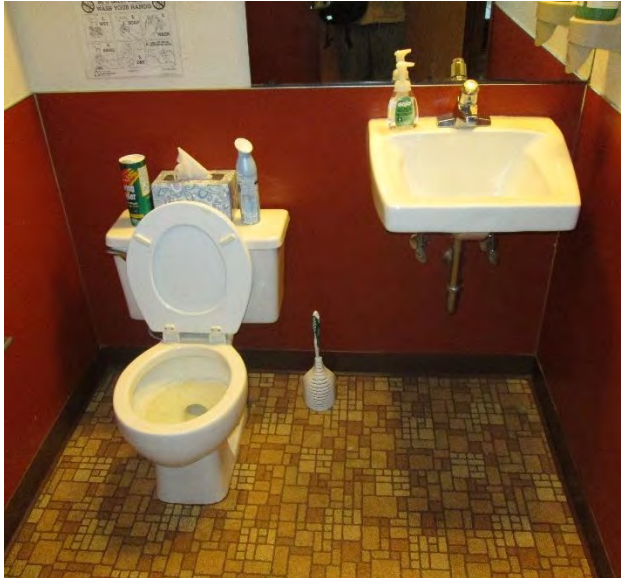
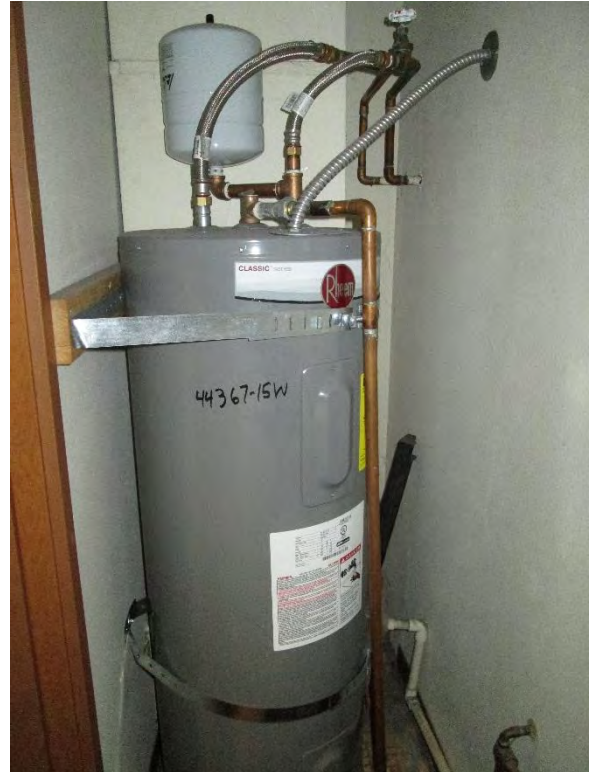
- g. Drains: The apparatus bay has square traffic drains in each bay.
 - h. Piping: The domestic water service pipe is copper but did not appear to have insulation.

- i. Domestic hot water: The building is served by a residential electric water heater, in good condition.
3. **Natural Gas Service:** The building does not currently have natural gas service.

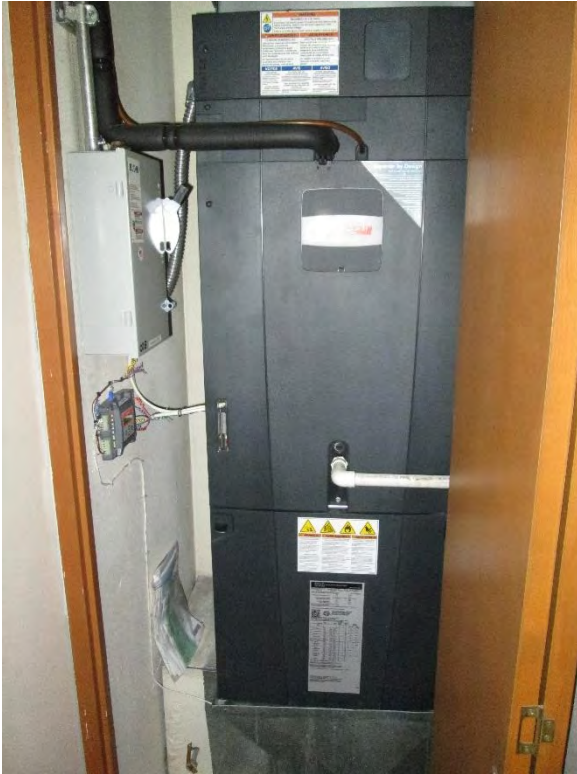
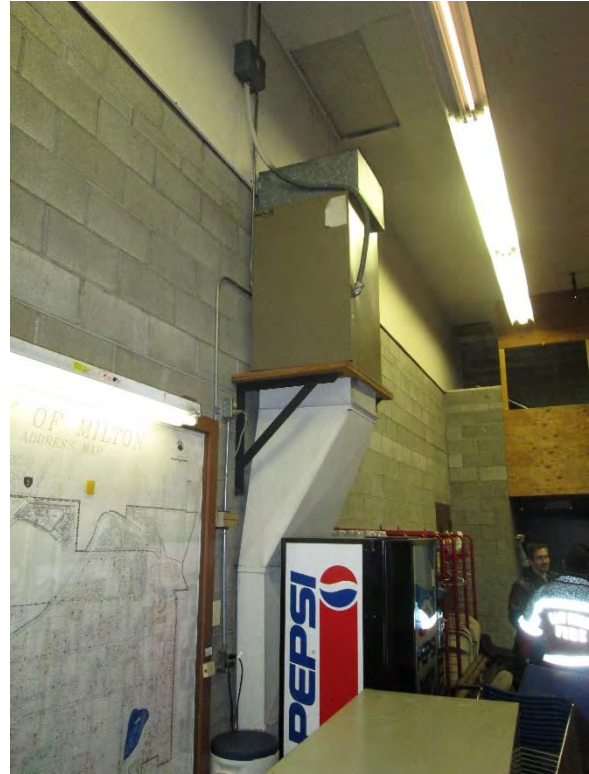
- d. Exhaust: The restrooms are provided with source specific exhaust.
 - e. Apparatus Bay: The apparatus bay is served by two electric forced air heaters which discharge air through the floor drains. The bays do not have a vehicle engine exhaust extraction system.

- f. Kitchen: The kitchen has a residential style electric range with a residential type range hood exhaust. This system offers limited odor and grease capture and should be considered inadequate for this application.

1. **Operational Related:**
 - a. Plan on providing a vehicle exhaust capture system. (Such ventilation would be required in a new station per WAC 296-305-06511(4).)
